# East Texas Recreational Use Attainability Analyses Project Comprehensive Report

Sabine River Basin – South Fork of the Sabine River (Segment 0507G); Elm Creek (Segment 0512B); Running Creek (Segment 0512A); Caney Creek (Segment 0502B)

Contract No. 582-9-90439-11

**AUGUST 2011**

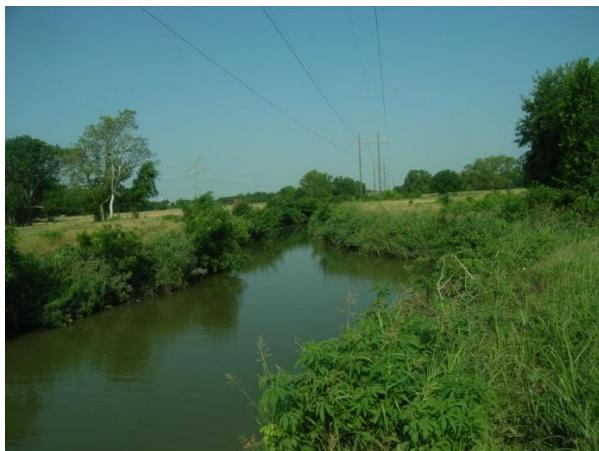
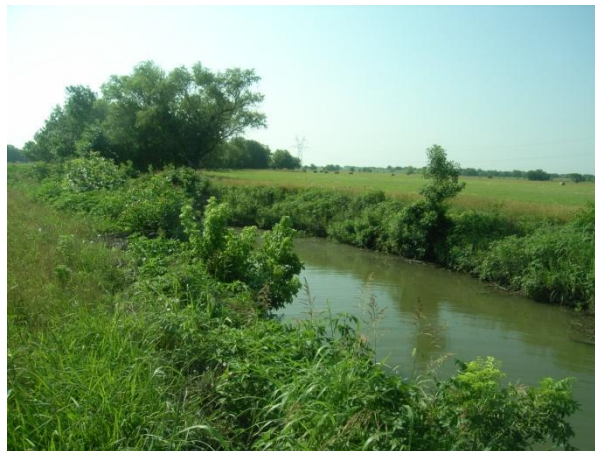
**Figure 4.3 South Fork of the Sabine River, Survey Site SF001**

**Site SF001 Private Property off Private Road 2030  
Upstream View**

**Site #SF001 Private Property off Private Road 2030  
Downstream View**

Water flow was measured along the entire length of the South Fork of the Sabine River. Three sites – SF001, SF002, and 18 - were surveyed along subsegment 0507G\_04. At Site SF001 a flow of 5.91 cubic feet per second (cfs) was measured in 2011. Average thalweg depth measured during the first survey was 1.14m and 1.02m during the second survey. No pools greater than 1.0m in depth were recorded. Neither primary nor secondary contact recreation was observed at Site SF001. Figure 4.3 displays the riparian characteristics of the private property along the stream at Site SF001.

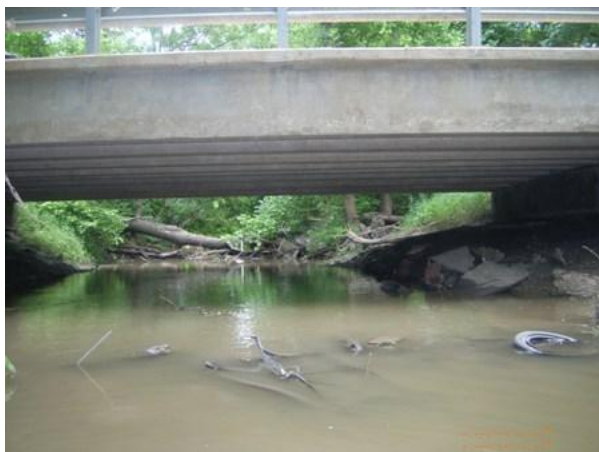
**Figure 4.4 South Fork of the Sabine River, Survey Site #15**

**Site #15 (above bridge) at CR 2400 Downstream View**

**Site #15 (below bridge) at CR 2400 Downstream View**

Three sites – 15, SF005, and 16 - were surveyed along subsegment 0507G\_02. Site 15 is publicly accessible from County Road 2400. Transects for Site 15 were surveyed upstream of County Road 2400. At this site flow measured 5.89 cfs in 2010 and 2.43 cfs in 2011. No pools greater than 1.0m in depth were recorded in the 2010 or 2011 survey (however, some stretches were too deep to measure in 2010). From the 2010 survey, the average thalweg depth was 0.94m and the 2011 survey recorded an average thalweg depth of 0.5m. Figure 4.4 displays the road crossing and

the thickly vegetated stream banks at Site 15. Site characteristics recorded at this site included log jams, abundant garbage, pungent odors emanating from the water, muddy bottom, and steep banks. Dense stream bank vegetation and no trespassing signs adjacent to the road were observed but there was indirect evidence of secondary and noncontact recreation.

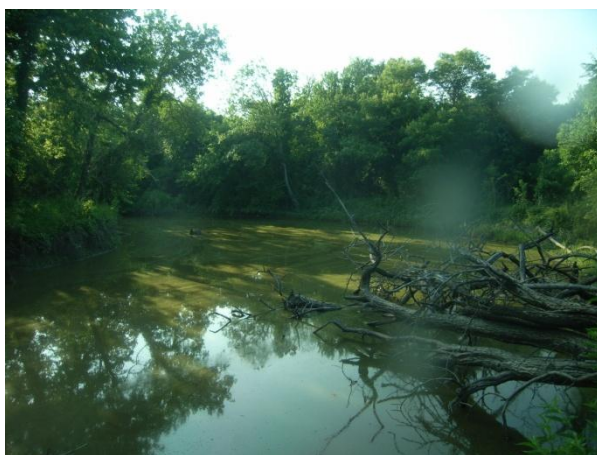
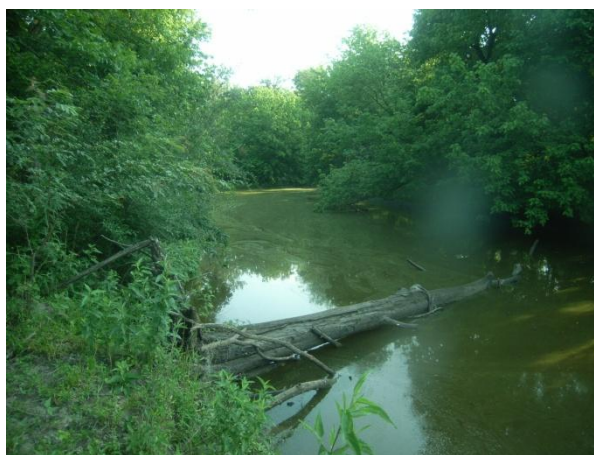
**Figure 4.5 South Fork of the Sabine River, Survey Site SF007**

**Site SF007 Private Property off State Highway 34 S  
Upstream View**

**Site SF007 Private Property off State Highway 34 S  
Downstream View**

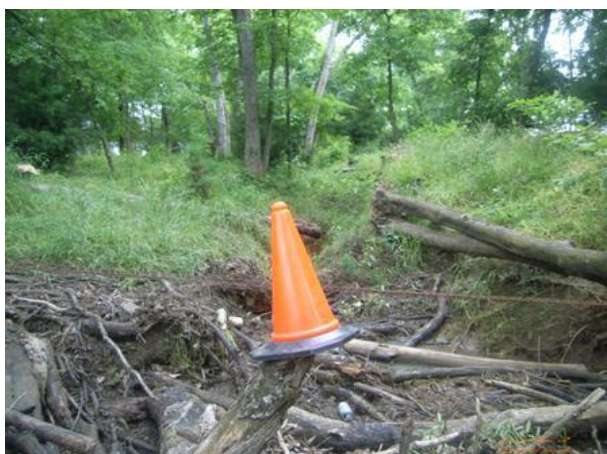
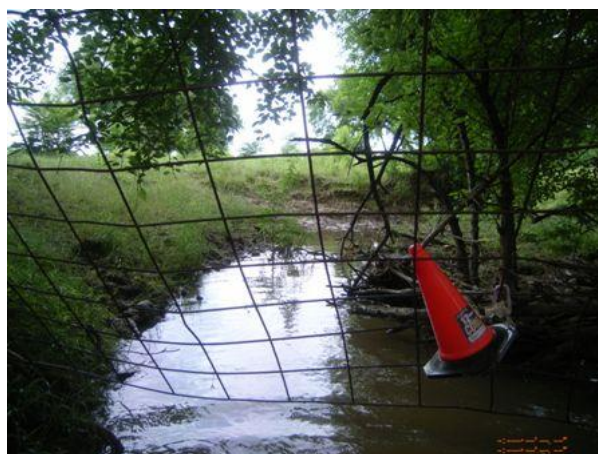
**Figure 4.7 Elm Creek, Survey Site #49**

**Site #49 at County Road 1110 Upstream View**

**Site #49 at County Road 1110 Downstream View**

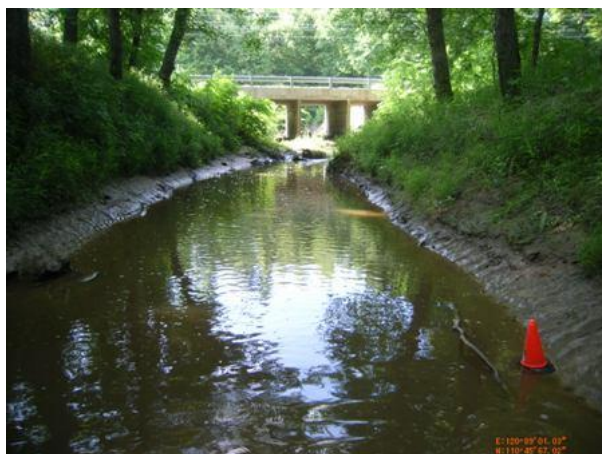
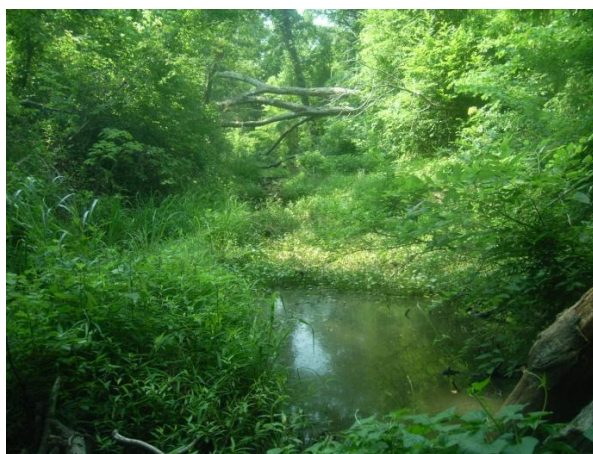
**Figure 4.9 Elm Creek, Survey Site #45**

**Site #45 at FM 1567 Upstream View**

**Site #45 at FM 1567 Downstream View**

Site 45, located at FM 1567 was identical in almost all aspects to Site 44. Steep, heavily vegetated banks, minimal water flow that was not measurable, household garbage and large, and numerous western cottonmouth water moccasins were recorded. The average thalweg depth measured in 2010 was 0.41m and 0.28m in 2011. No pools greater than 1.0m in depth were recorded during either survey. No primary or secondary contact recreation was observed and no evidence of previous recreation was likewise identified. Figure 4.9 displays the steep banks and thick vegetation of the Elm Creek riparian area along Site 45.

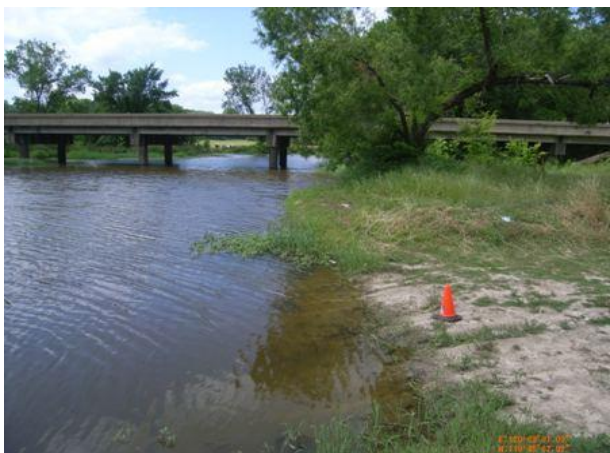
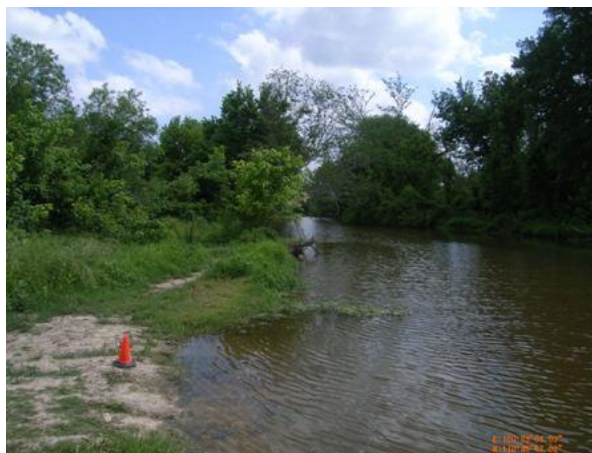
**Figure 4.10 Elm Creek, Survey Site #42**

**Site #42 at FM 514 Upstream View**

**Site #42 at FM 514 Downstream View**

could be collected. In 2010 one measurement was taken at the 30m transect, which recorded the stream depth at 2.42m. From the 2011 survey, the thalweg depth averaged 1.22m, and flow was measured at 3.45 cfs, which was considerably greater than any upstream sites. No pools greater than 1.0m depth were recorded during either survey. Public accessibility was possible from an unimproved parking area beside the FM 514 bridge. No primary or secondary contact recreation was observed during either site survey. Evidence of recreation activities were evident from fire pits, foot paths leading to the creek, and discarded fishing tackle. Other site conditions recorded included garbage, slippery creek bed, and the presence of western cottonmouth water moccasins.

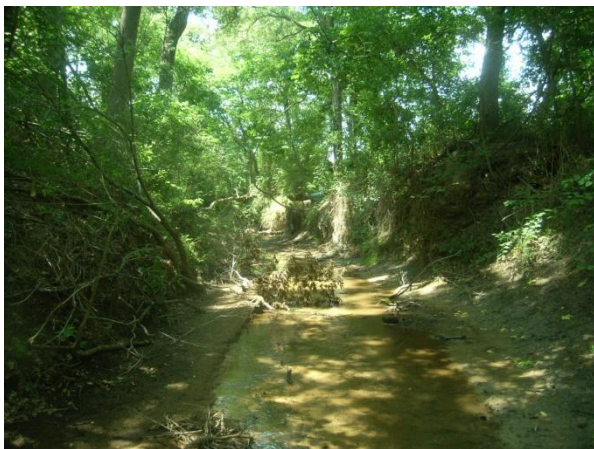
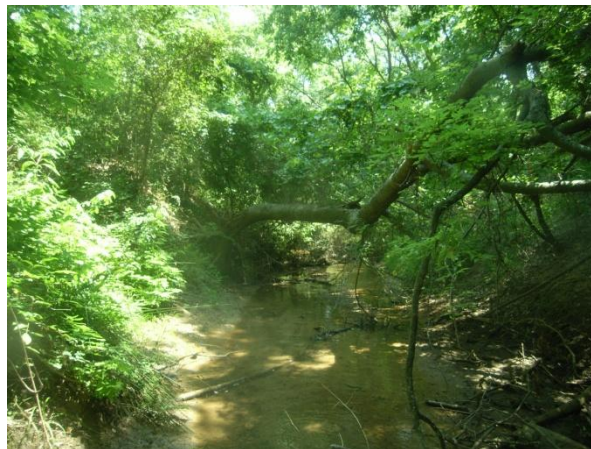
**Figure 4.13 Running Creek, Survey Site RC001**

**Site RC001 Private Property Upstream View**

**Site RC001 Private Property Downstream View**

Along the upper most subsegment 0512A\_03, surveys were conducted at two different sites – RC001 and RC002. The most upstream site surveyed on Running Creek was Site RC001, which is located on private property (Elberta Lake Club) immediately downstream from Elberta Lake. The creek just below Elberta Lake is perennial and water flow at this site was measured at 0.83 cfs in 2010 and 0.46 cfs in 2011. During the surveys the average thalweg depths were 0.25m and 0.19m. Pool depths measured were 0.78m and 0.5m. Site conditions recorded included aquatic life, garbage, log jams, and very steep, vegetated slopes with mature trees and dense canopy. Figure 4.13 displays the steep banks and dense vegetation typical of the private property that borders Running Creek at Site RC001. Public access at this site is not possible and no primary or secondary contact recreation was observed and no evidence of recreational use was recorded.

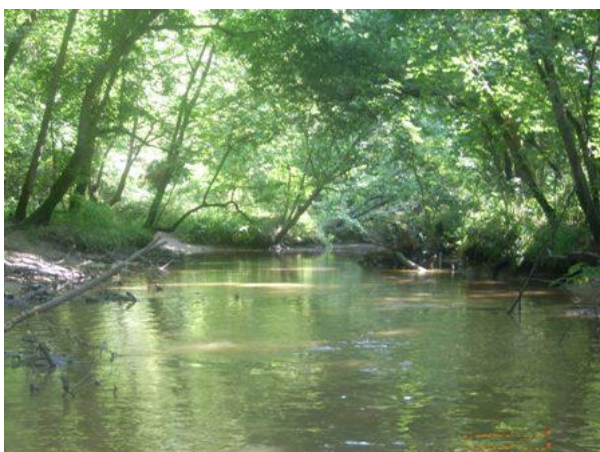
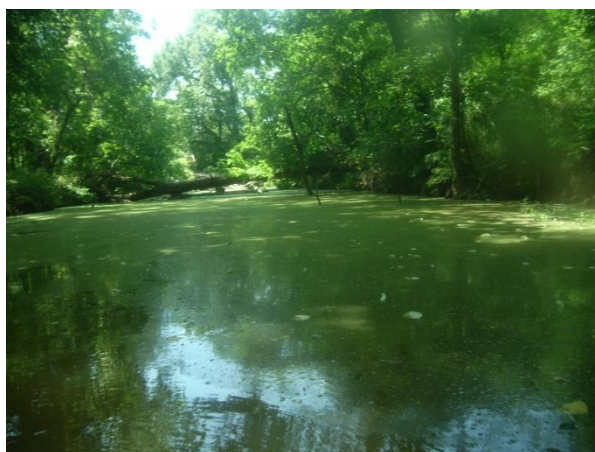
**Figure 4.14 Running Creek, Survey Site #50**

**Site #50 at County Road 2436 Upstream View**

**Site #50 at County Road 2436 Downstream View**

Surveys were conducted at four different sites along subsegment 0512A\_01 – sites 50, RC004, RC005, and RC006. Transects conducted at Site 50 located at County Road 2436 were taken downstream of the road. Stream flow was 6.71 cfs in May 2010; in June 2011, by contrast, there was no stream flow. The average thalweg depth in 2010 was 0.94m and 1.27m in 2011. No pools greater than 1.0m in depth were recorded during either survey. Despite sufficient water to support recreational contact, none was observed and public access was difficult. Lack of parking along County Road 2436, privately owned banks, steep, slippery banks, large household garbage, oil slicks, beaver dams, and log jams across the entire stream bed were documented. Photographs in Figure 4.14, taken downstream of County Road 2436 display the dense riparian vegetation, fallen trees, and water surface conditions. Foot paths and fishing gear provided evidence of secondary and noncontact recreation activity at Site 50.

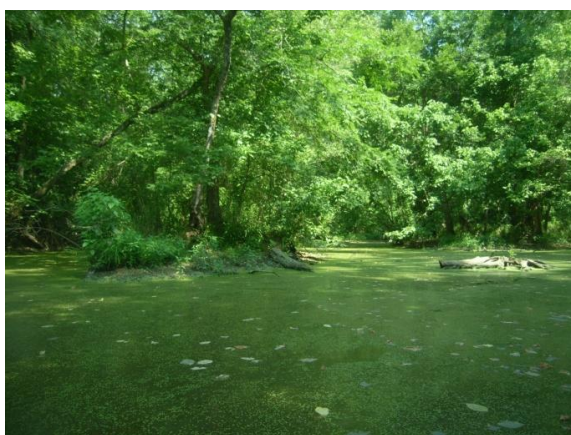
**Figure 4.15 Running Creek, Survey Site RC005**

**Site RC005 Private Property off County Road 2432  
Upstream View**

**Site RC005 Private Property off County Road 2432  
Downstream View**

The last two sites surveyed, Sites RC005 and RC006, are located on private property. As with Site RC004, Sites RC005 and RC006 had variable water flow (none the first visit and up to 1.54 cfs on the second). The average thalweg depth at Site RC005 was 0.43m and 0.6m on the first and second visits, respectively. The average thalweg depth measured at Site RC006 was 0.75m from the first survey and 0.51m from the second survey. Exclusion of the general public on private property, steep vegetated banks, thick, overhanging branches, thick algal mats, log-strewn stream bottom and the presence of western cottonmouth water moccasins all discouraged human contact with the water. The photographs in Figure 4.15 display the dense algal mat and woody debris on the water surface, which is prevalent throughout Site RC005 and the thick riparian vegetation along both stream banks. Neither primary nor secondary contact recreation was observed during surveys. The only evidence of noncontact recreation activities included ATV trails and duck and deer hunting blinds from the previous hunting season.

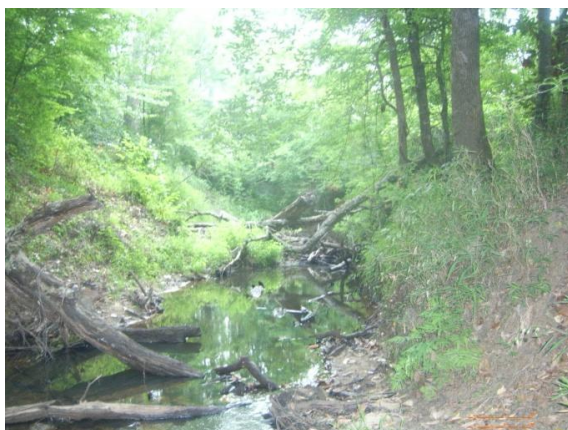
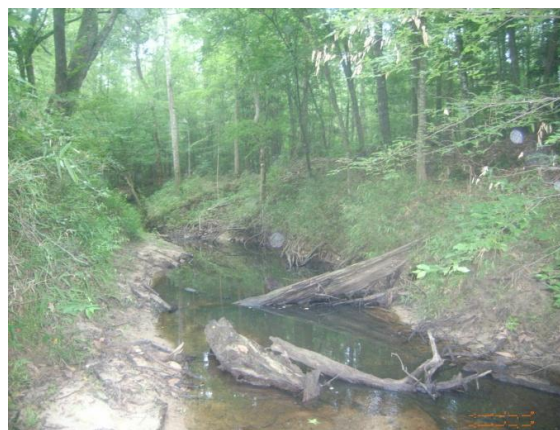
**Figure 4.18 Caney Creek, Survey Site CC001**

**Site CC001 Private Property Upstream View**

**Site CC001 Private Property Downstream View**

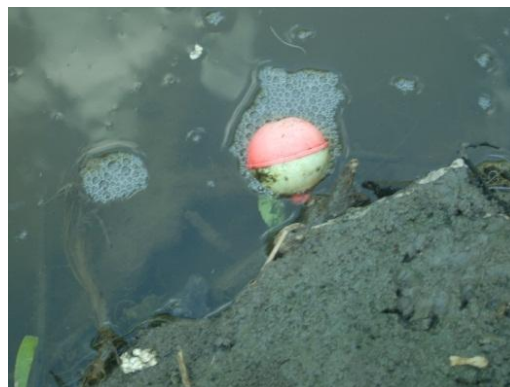
**Discarded fishing bobber**

observed, there was evidence of previous recreation activity, including discarded fishing tackle and items of clothing. Other site characteristics recorded include steep stream banks with dense vegetation, frequent log jams, lack of water flow, and debris in the channel.

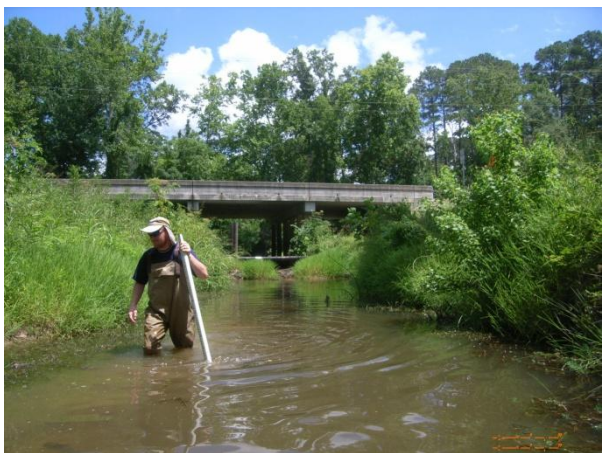
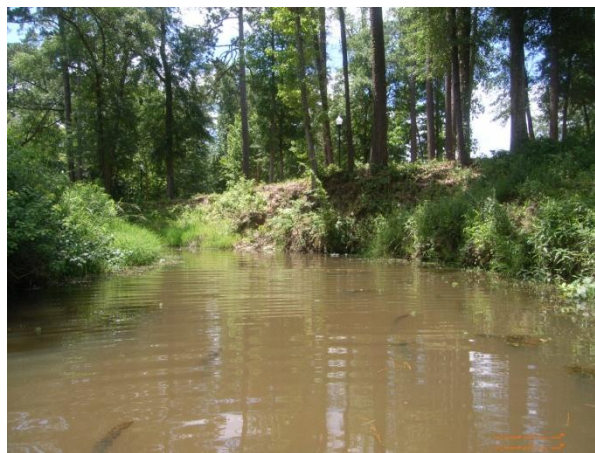
**Figure 4.19 Caney Creek, Survey Site #62**

**Site #62 at U.S. Hwy 190 Upstream View**

**Site #62 at U.S. Hwy 190 Downstream View**

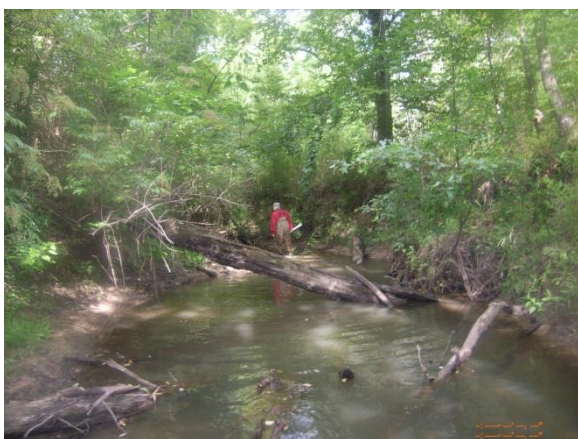
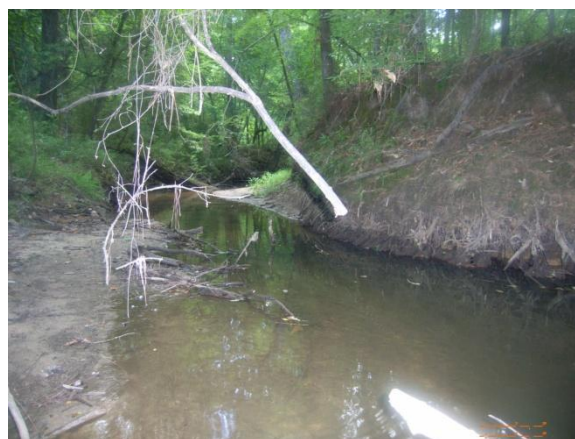
**Figure 4.20 Caney Creek, Survey Site #CC004**

**Site CC004 Private Property off of Lee's Mill Road  
Upstream View**

**Site CC004 Private Property off of Lee's Mill Road  
Downstream View**

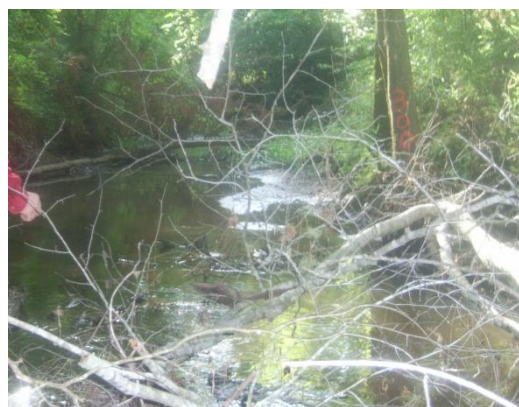
**Figure 4.21 Caney Creek, Survey Site CC005**

**Site CC005 Private Property off of Lee's Mill Road  
Upstream View**

**Site CC005 Private Property off of Lee's Mill Road  
Downstream View**

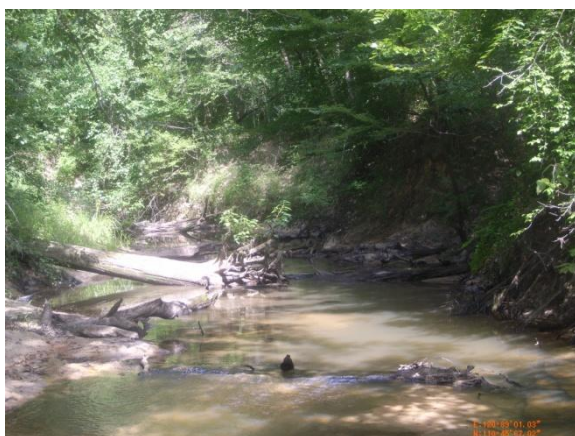
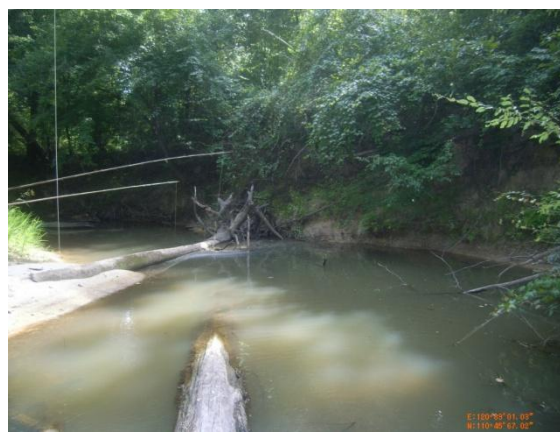
**Figure 4.22 Caney Creek, Survey Site #59**

**Site 59 at FM 2626 Upstream View**

**Site 59 at FM 2626 Downstream View**

The next subsegment, 0502B \_02, had two survey sites – 59 and CC006. Site 59 was accessible to the public from FM 2626 with some residences close by. Transects for Site 59 were performed upstream of FM 2626. Flow was 3.84 cfs the first visit and 1.31 cfs the second visit. Thalweg depths averaged 0.54m for the 2010 survey and 0.27m for the 2011 survey. Pools were over 20m long and up to 1.1m deep, and mature riverine forests were present along both banks. Primary contact recreation was not observed during either survey. Evidence of previous fishing was documented, including discarded tackle and fishing poles on the bank of one adjoining home. Figure 4.22 displays the frequent fallen trees and debris in the creek, steep banks with heavy vegetation and fishing poles anchored in the stream bank.

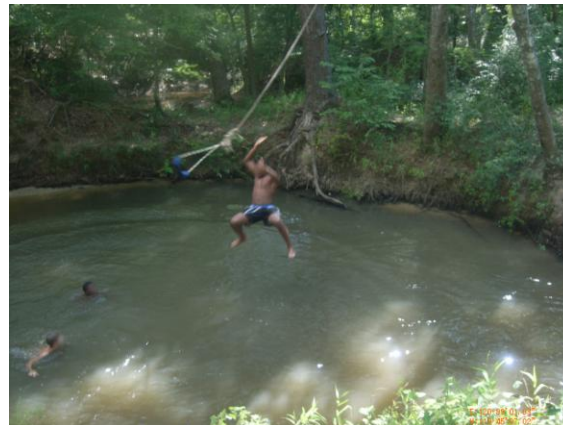
**Figure 4.23 Caney Creek, Survey Site #58**

**Kids at a popular swimming hole at Site #58**

Site 58, located at Jones Road, had measured flows of 3.55 cfs during the first visit and 7.25 cfs the second visit. Transects for Site 58 were performed upstream of Jones Road. Average thalweg depths were 0.33m from the 2010 survey and 0.48m from the 2011 survey. Pools up to 35m long, 20m wide, and up to 1.2m deep were recorded. Houses were located nearby, an unimproved parking area was observed, and signs of swimming were apparent at a site, including a rope swing. On a subsequent visit, swimming was witnessed by the team during a drive by. Easy public access, footpaths, and discarded flotation devices were also documented around this site. Fishing appears to be common, as documented by field team observations and indicated by interviews. Figure 4.23 provides photographs of the Caney Creek at Site 58.

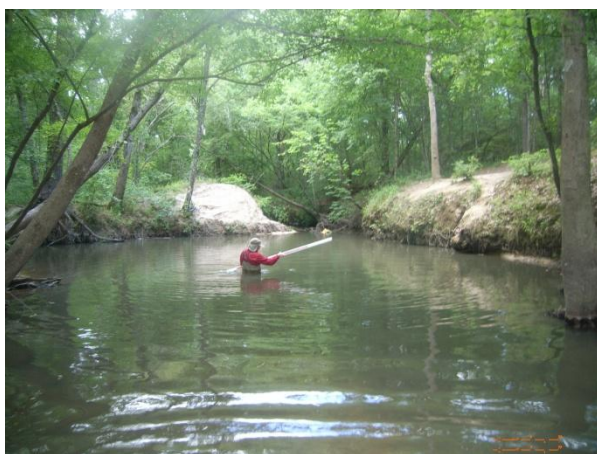
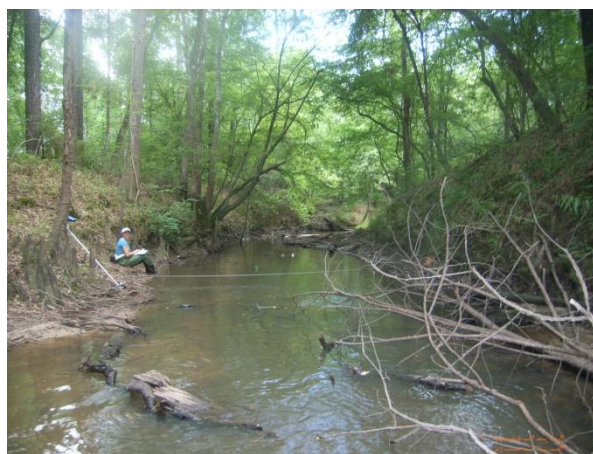
**Site #58 at Jones Road Upstream View**

**Site #58 at Jones Road Downstream View**

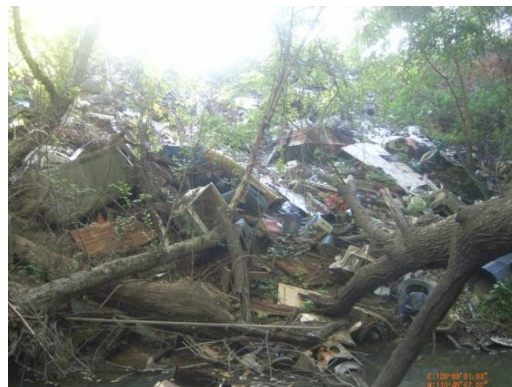
**Trash dump along stream bank at Site #57**

The most downstream site surveyed was Site 57, which is publicly accessible from Sabine Sands Road. Transects for Site 57 were performed upstream of Sabine Sands Road. This site is located very close to the confluence with the Sabine River. Stream flow measured during the 2010 survey was 9.32 cfs and 3.21 cfs during the 2011 survey. Average thalweg depths were 0.39m from the 2010 survey and 0.3m from the 2011 survey. Pool lengths went to 24m, widths up to 18m and depths up to 1.6m. No recreation activity was observed and no evidence of recreation was recorded at Site 75. This
